The Fire Resistance Performance Of Three Horizontally Mounted, Access Panels, tested using the principles of BS EN 1634-1: 2014.

403834

Panel Technologies

29th May 2019

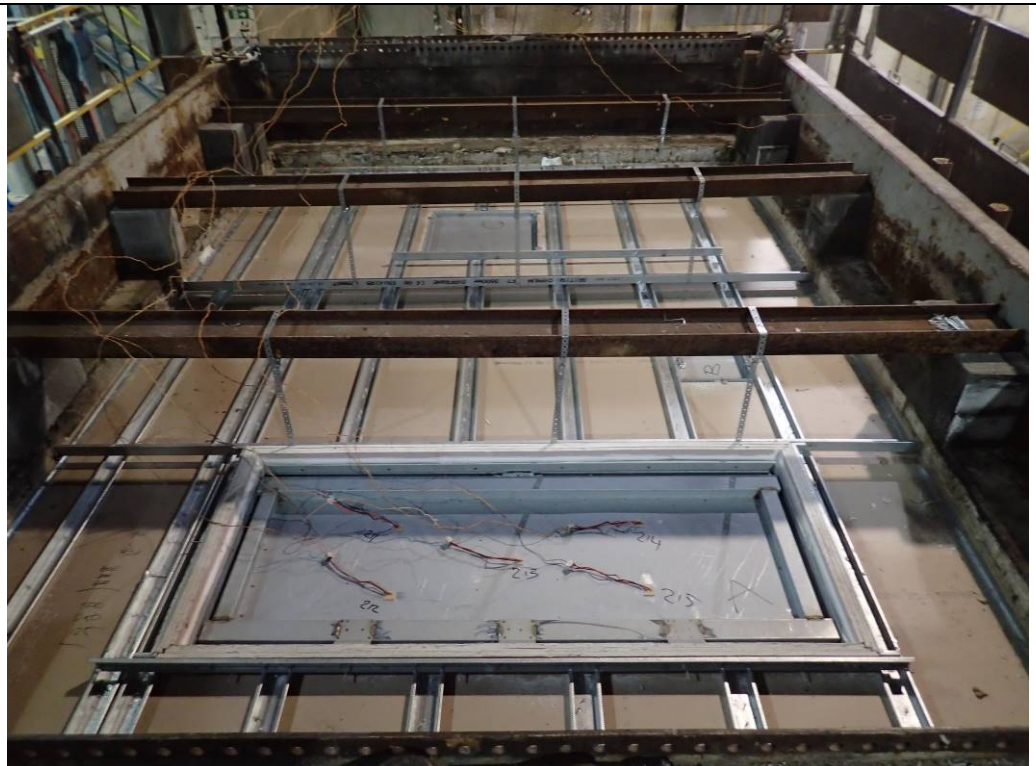
The unexposed face of the test assembly prior to the start of the test

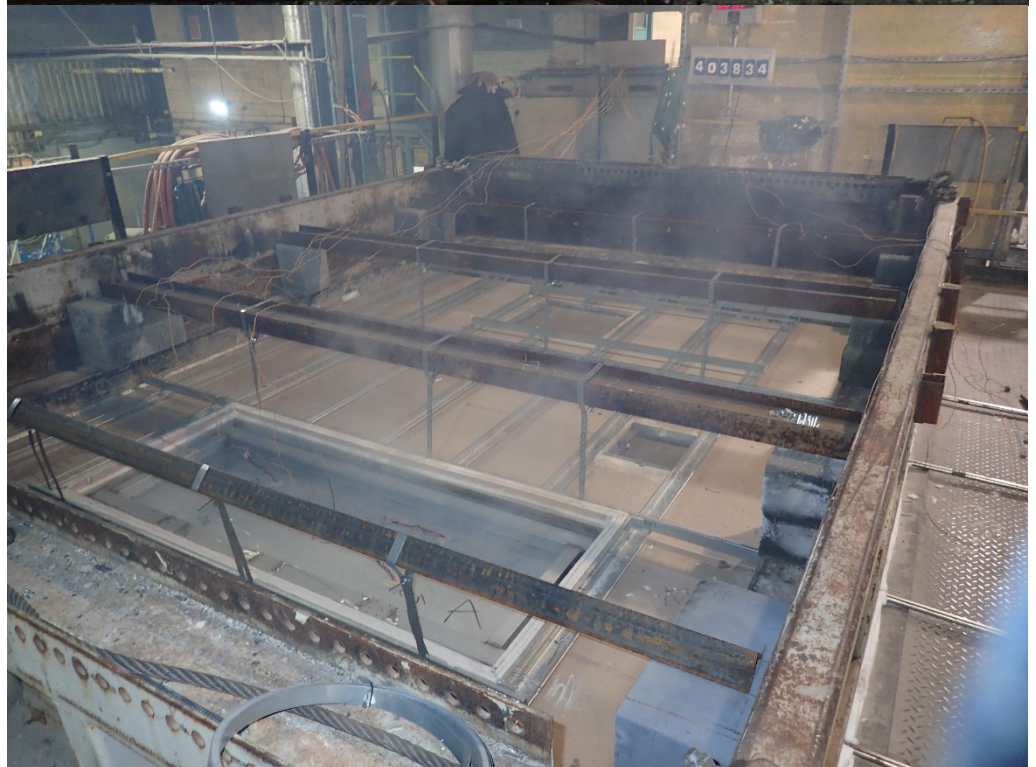
The unexposed face of the test assembly after a test duration of 20 minutes

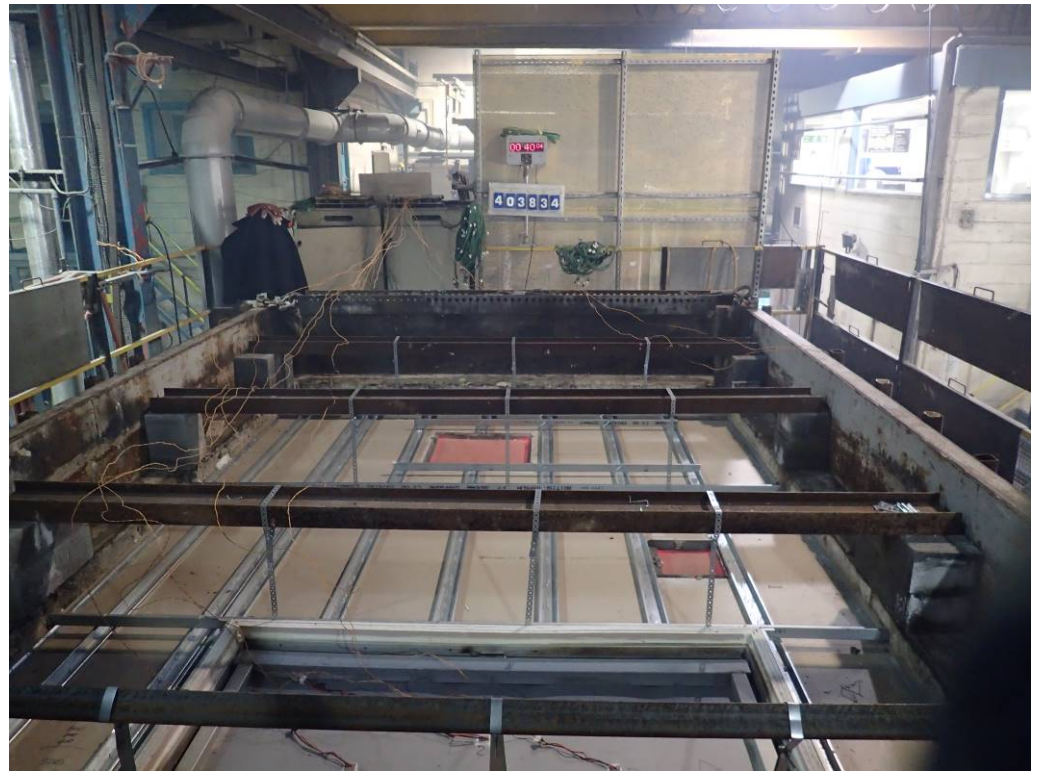
The unexposed face of the test assembly after a test duration of 40 minutes

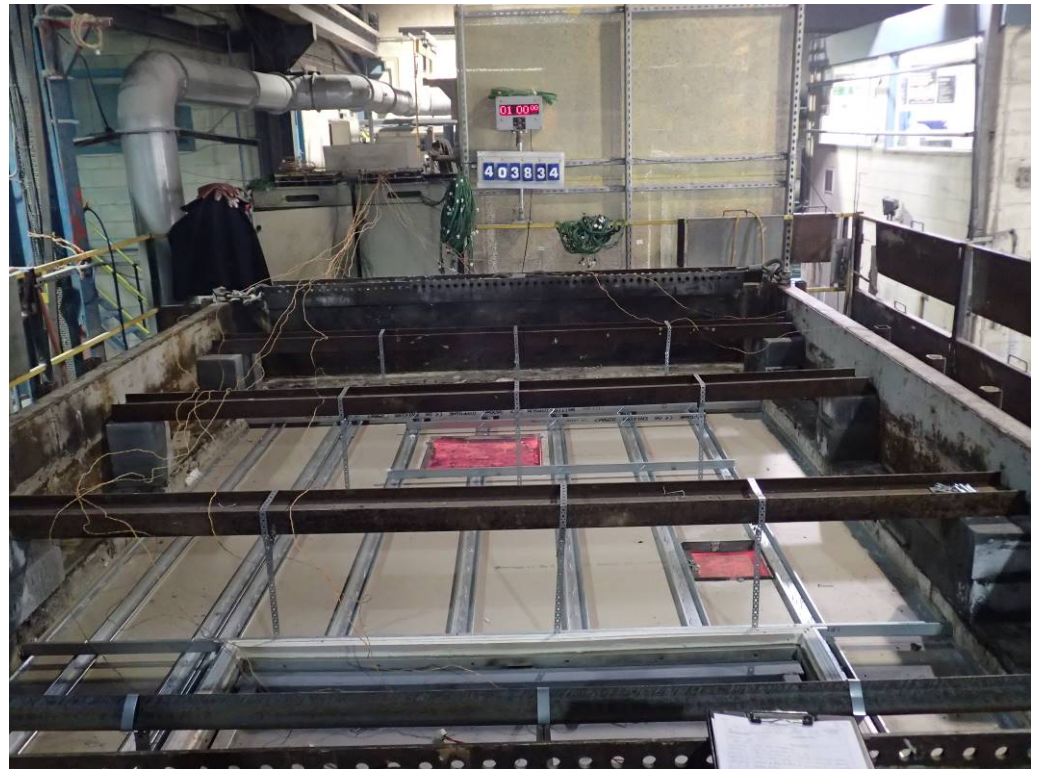
60	00	All hatches satisfy the sustained flame and gap gauge integrity criteria.
80	00	Viewed from the exposed face: The first layer of board begins to fall away into the furnace chamber.
90	00	No further significant changes are evident at this time.
93	00	More board falls into the furnace chamber.
120	00	Each hatch satisfies the sustained flaming and gap gauge criteria.
120	45	A through gap is evident on Hatch C in excess of 6mm by 150 mm. Gap gauge failure of Hatch C is deemed to occur.
124	00	A through gap is evident on Hatch B in excess of 6mm by 150 mm. Gap gauge failure of Hatch B is deemed to occur.
127	00	Hatch C falls into the furnace chamber. The test is discontinued at the request of the sponsor.

The unexposed face of the test assembly after a test duration of 60 minutes

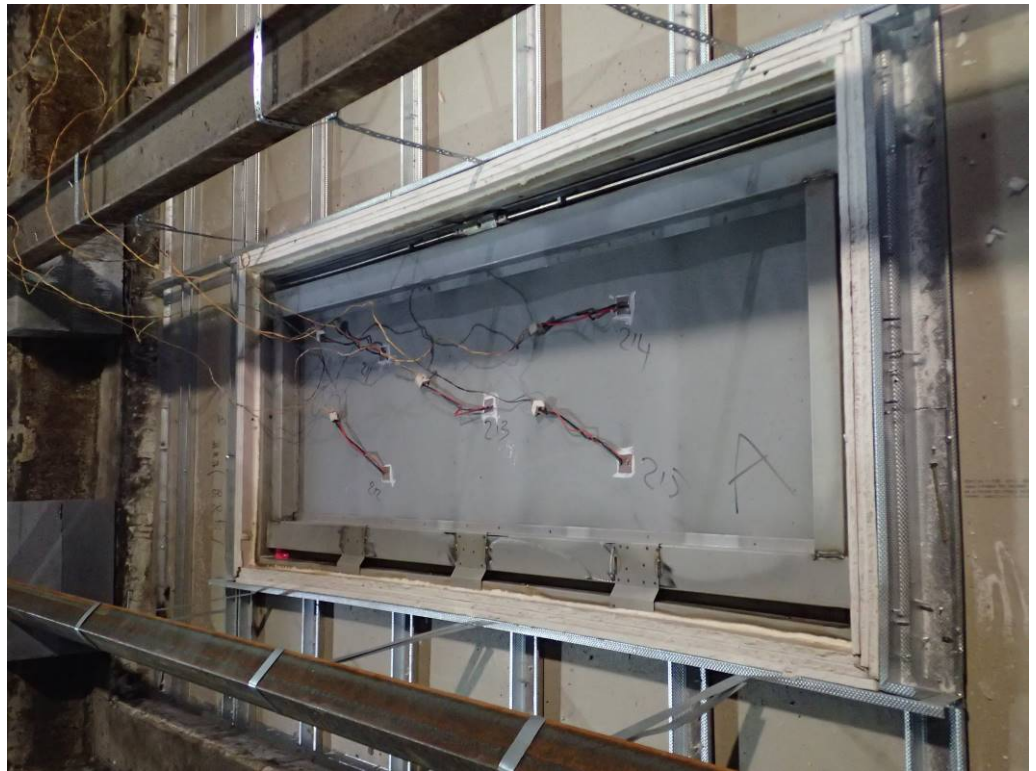
The unexposed face of the test assembly after a test duration of 60 minutes, showing Hatch A

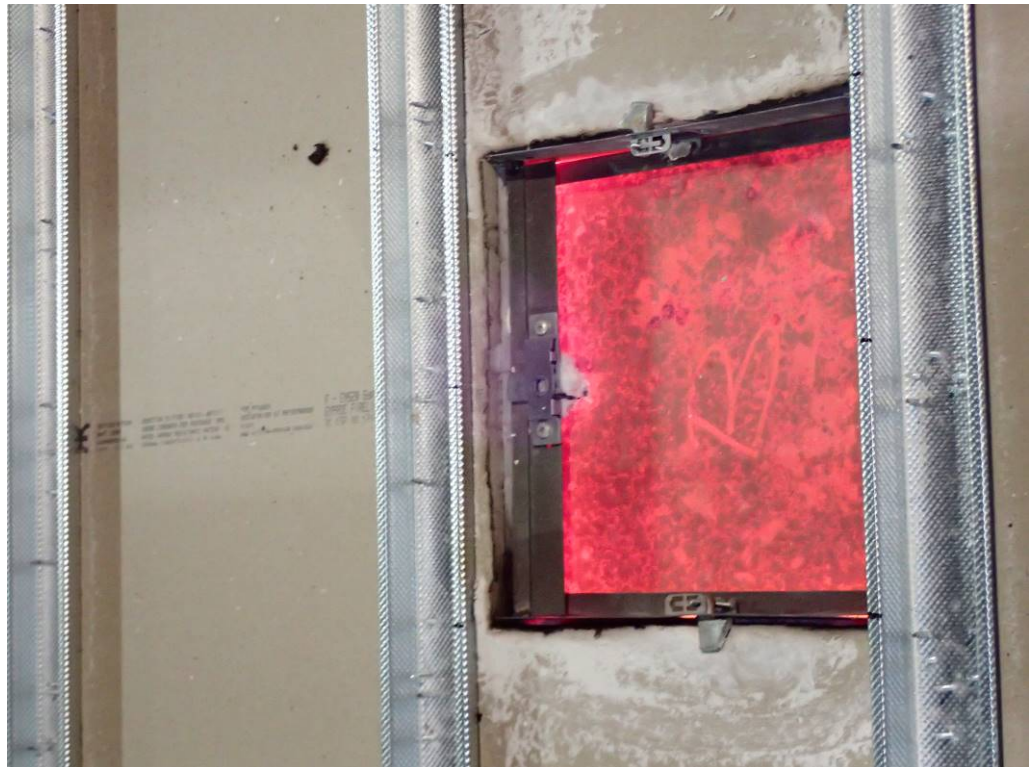
The unexposed face of the test assembly after a test duration of 60 minutes, showing Hatch B

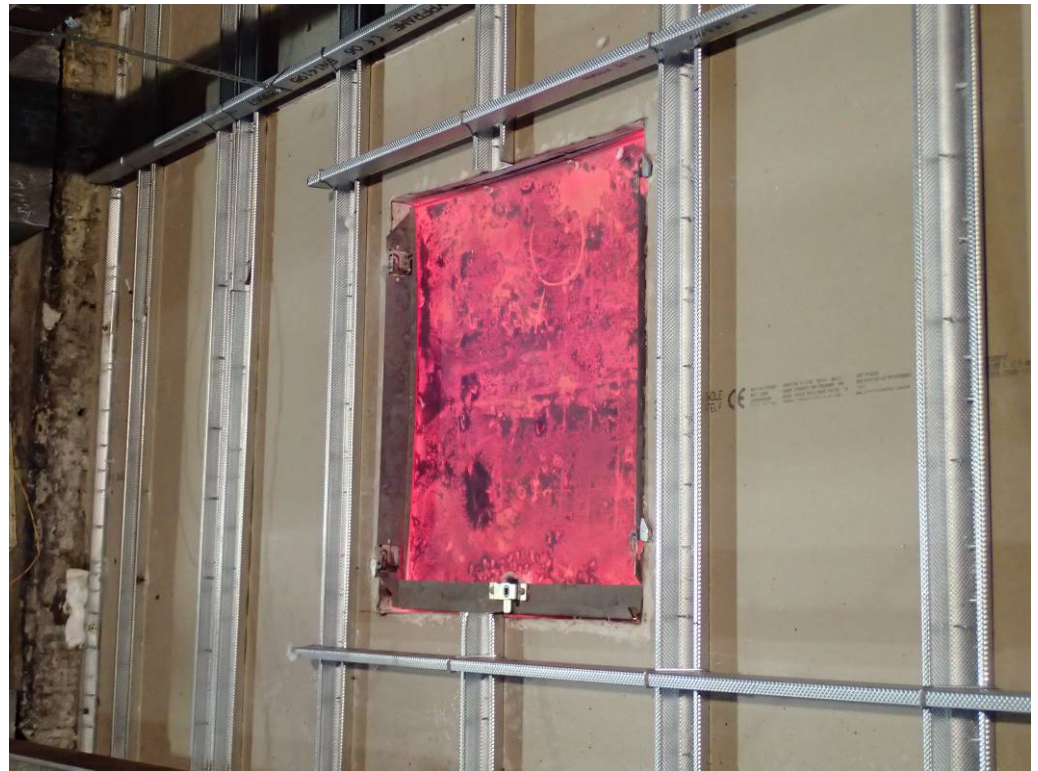
The unexposed face of the test assembly after a test duration of 60 minutes, showing Hatch C

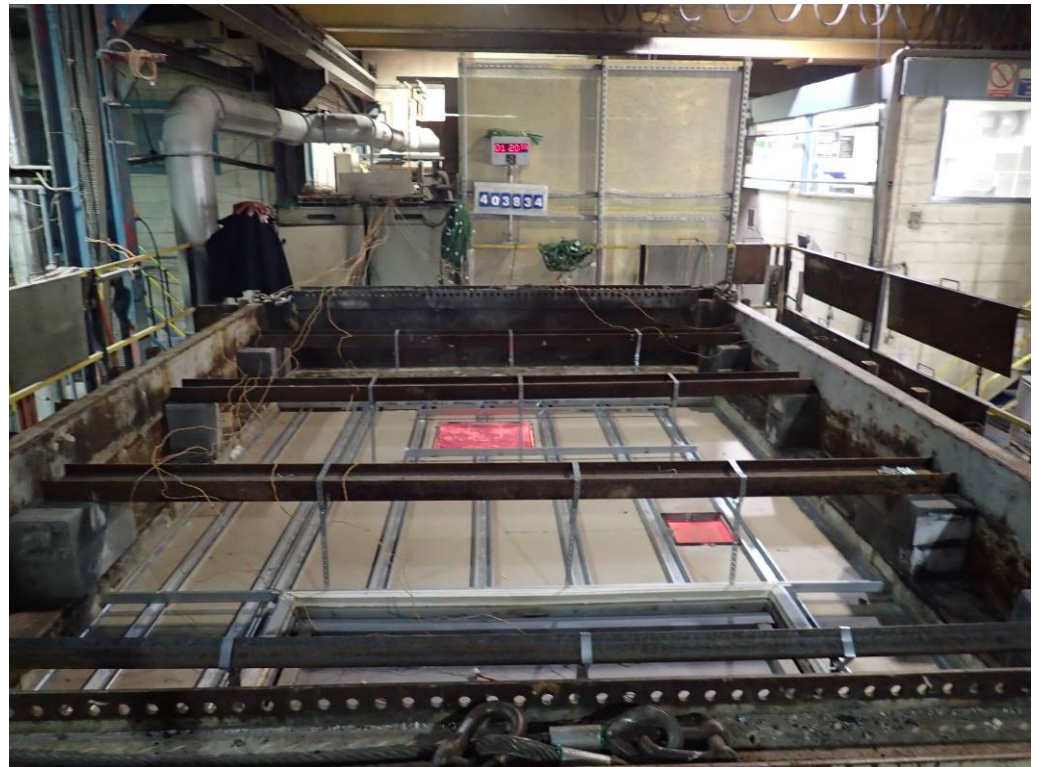
The unexposed face of the test assembly after a test duration of 80 minutes

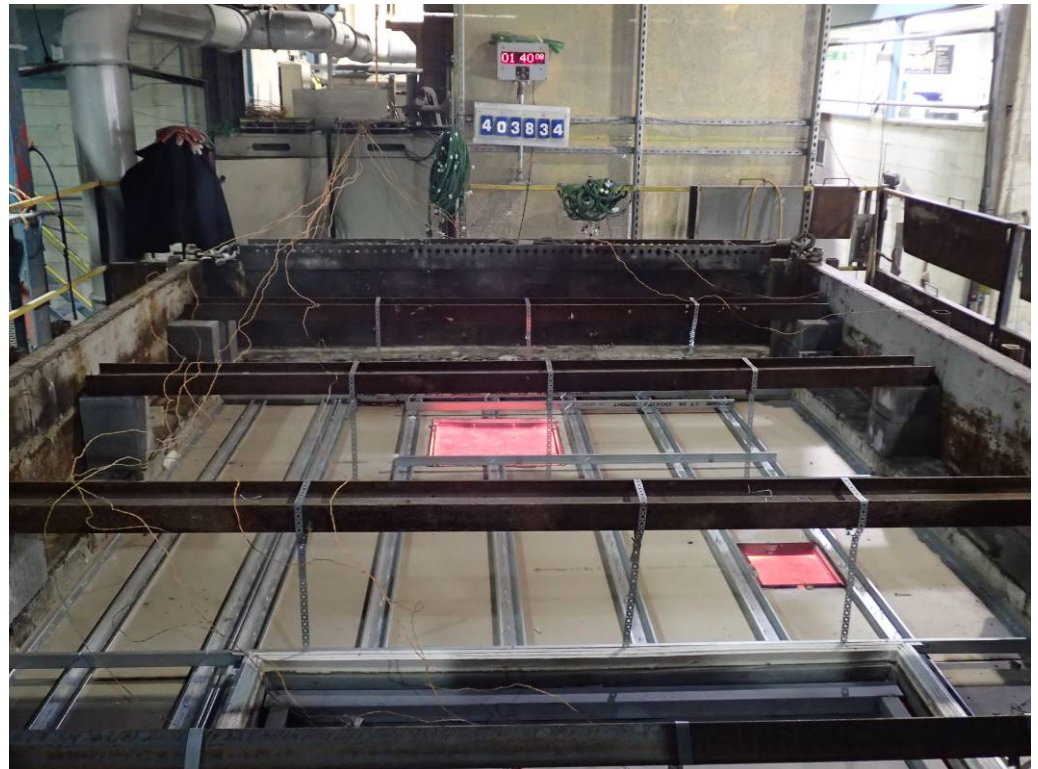
The unexposed face of the test assembly after a test duration of 100 minutes

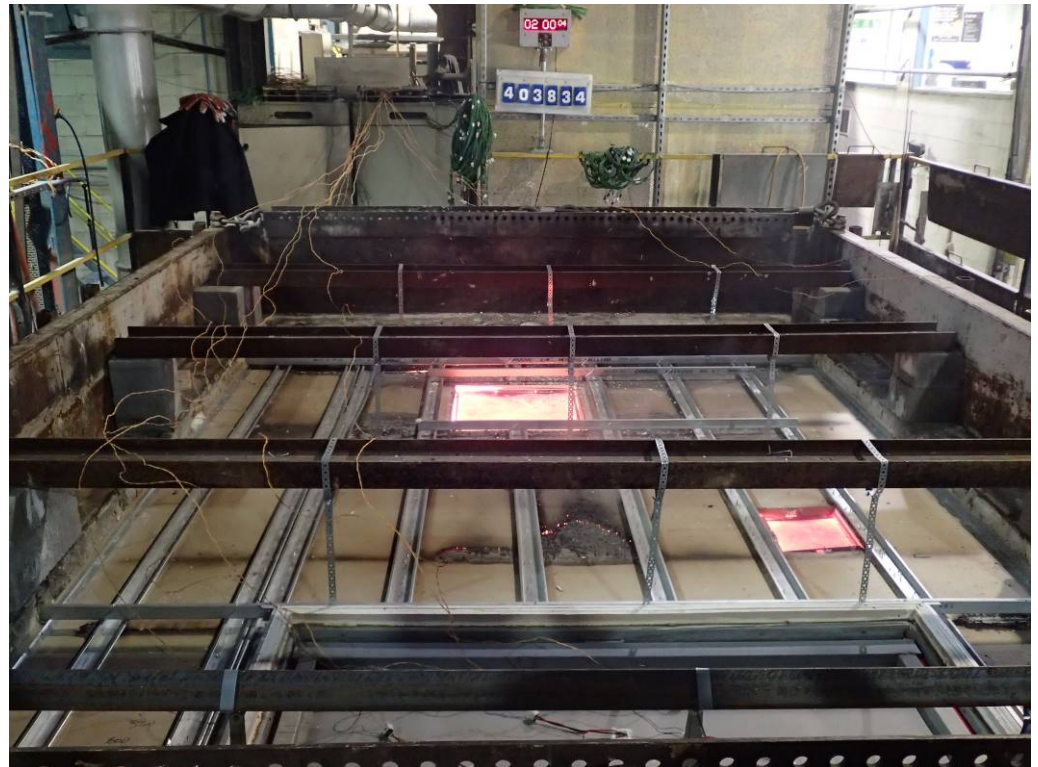
The unexposed face of the test assembly after a test duration of 120 minutes

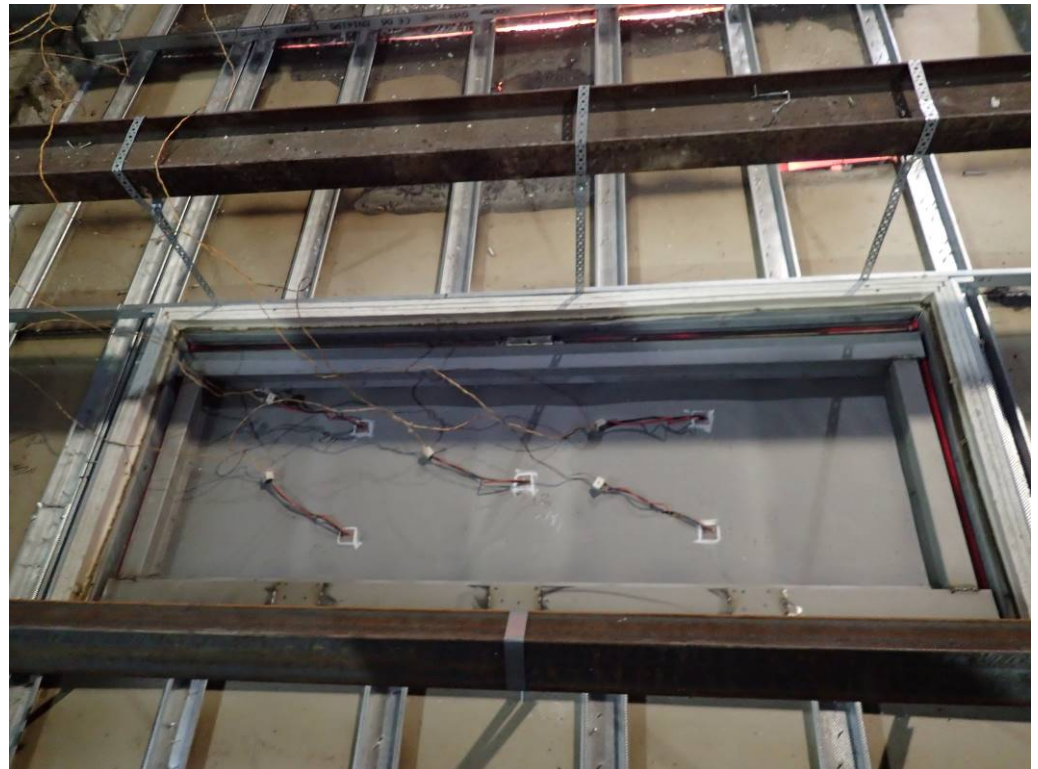
The unexposed face of the test assembly after a test duration of 120 minutes, showing Hatch A

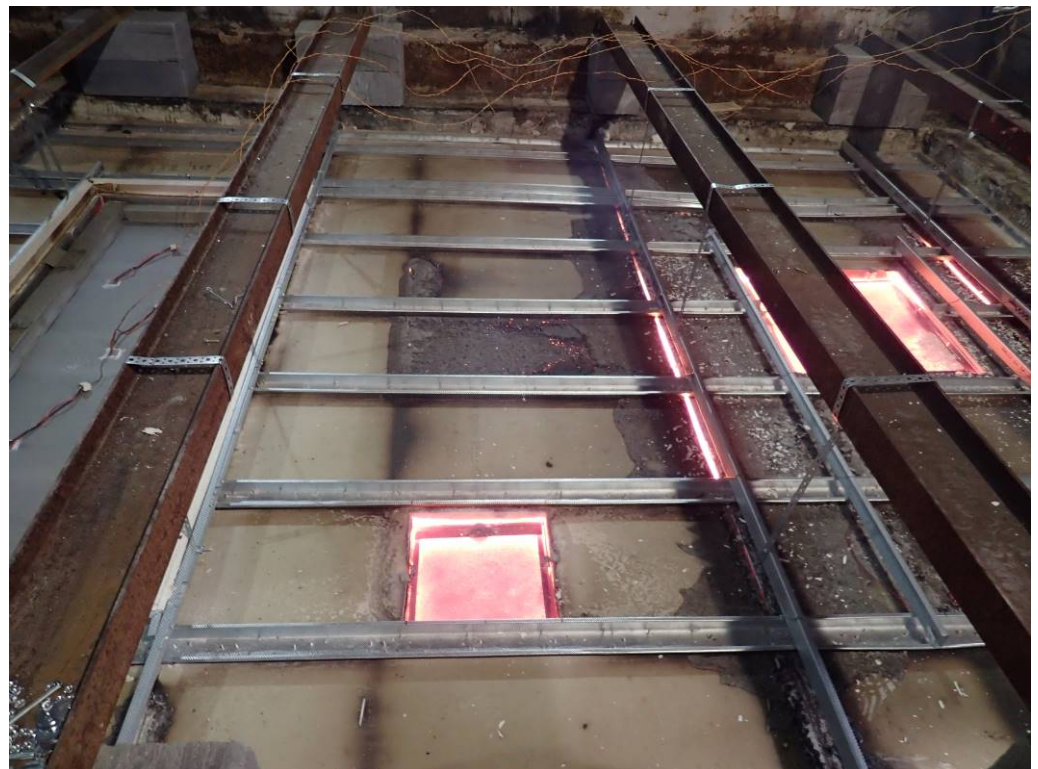
The unexposed face of the test assembly after a test duration of 120 minutes, showing Hatch B

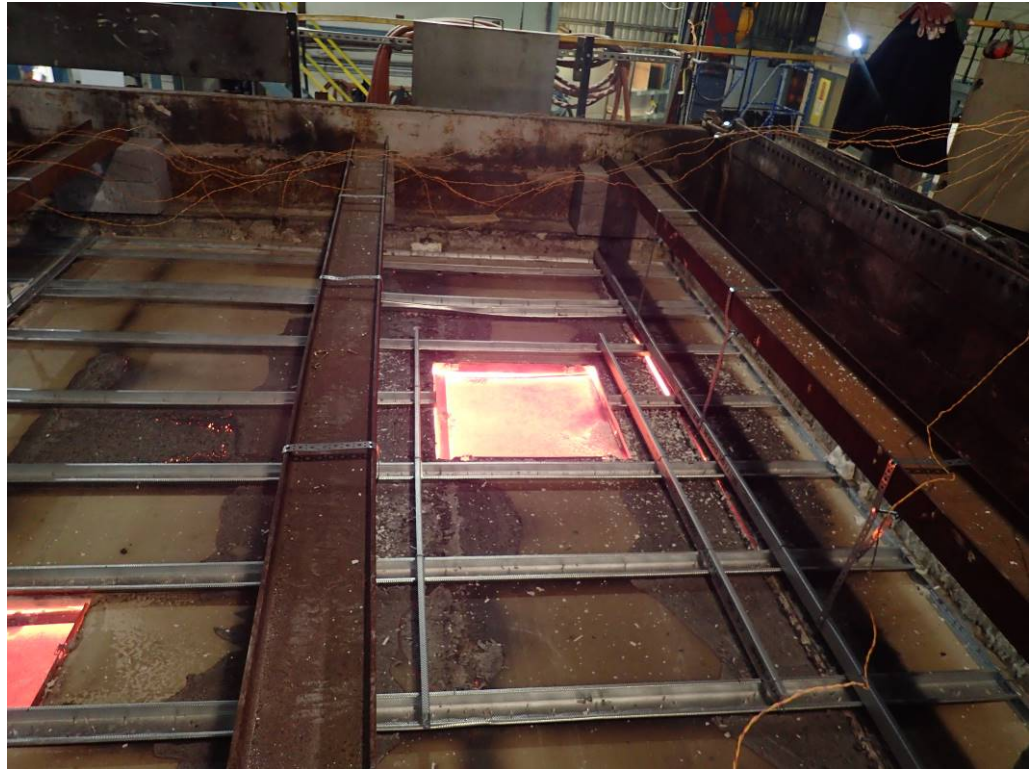
The unexposed face of the test assembly after a test duration of 120 minutes, showing Hatch C

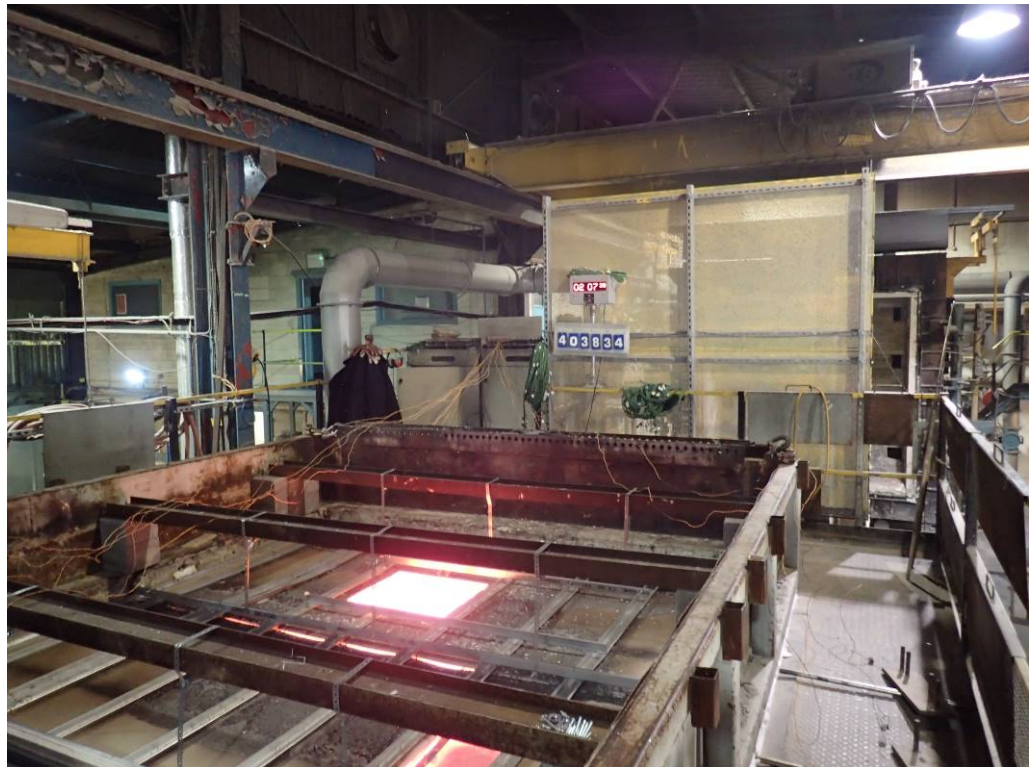
The unexposed face of the test assembly after a test duration of 127 minutes
