## I. FLAMMABILITY

### Standard Acheived

The Flammability result meets the requirement given in BS 7188:1998

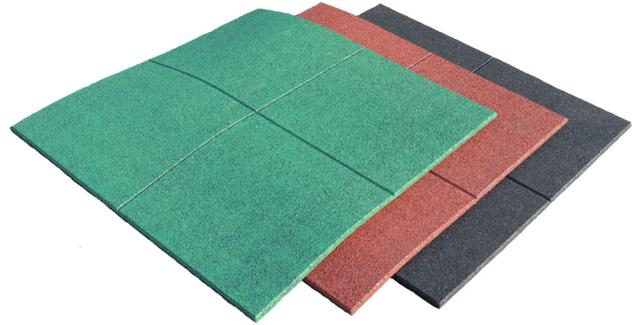
Section 7.1 of BS7188:1998 specifies that the radius of effect of ignition shall not exceed 35mm and shall thereby be classified as having a "LOW" radius of effects of ignition.

- This is assessed by the method of BS 4790 the 'Hot Metal Nut test'.
- In this test, a nut of defined size and mass and at a temperature of 900°C is placed on the surface.
- The area affected is measured and the results classified as "Low", "Medium" or "High" radius of effects of ignition.

<b>ACCURACY (+)</b>
<b>TIME FROM APPLICATION OF NUT TO EXTINCTION OF FLAME (S)</b>	226.198.167	(5)
<b>GREATEST RADIUS OF AFFECTED AREA (MM)</b>	15.15.1	N/A
<b>CLASSIFICATION : RADIUS OF EFFECTS OF IGNITION</b>
